ACCIDENT INVESTIGATION REPORT  
(UNDERGROUND COAL MINE)

NONSERIOUS INJURY OUTBURST (BOUNCE)

Castle Gate Mine (ID No. 42-00165)  
Castle Gate Coal Company  
Helper, Carbon County, Utah

November 7, 1988

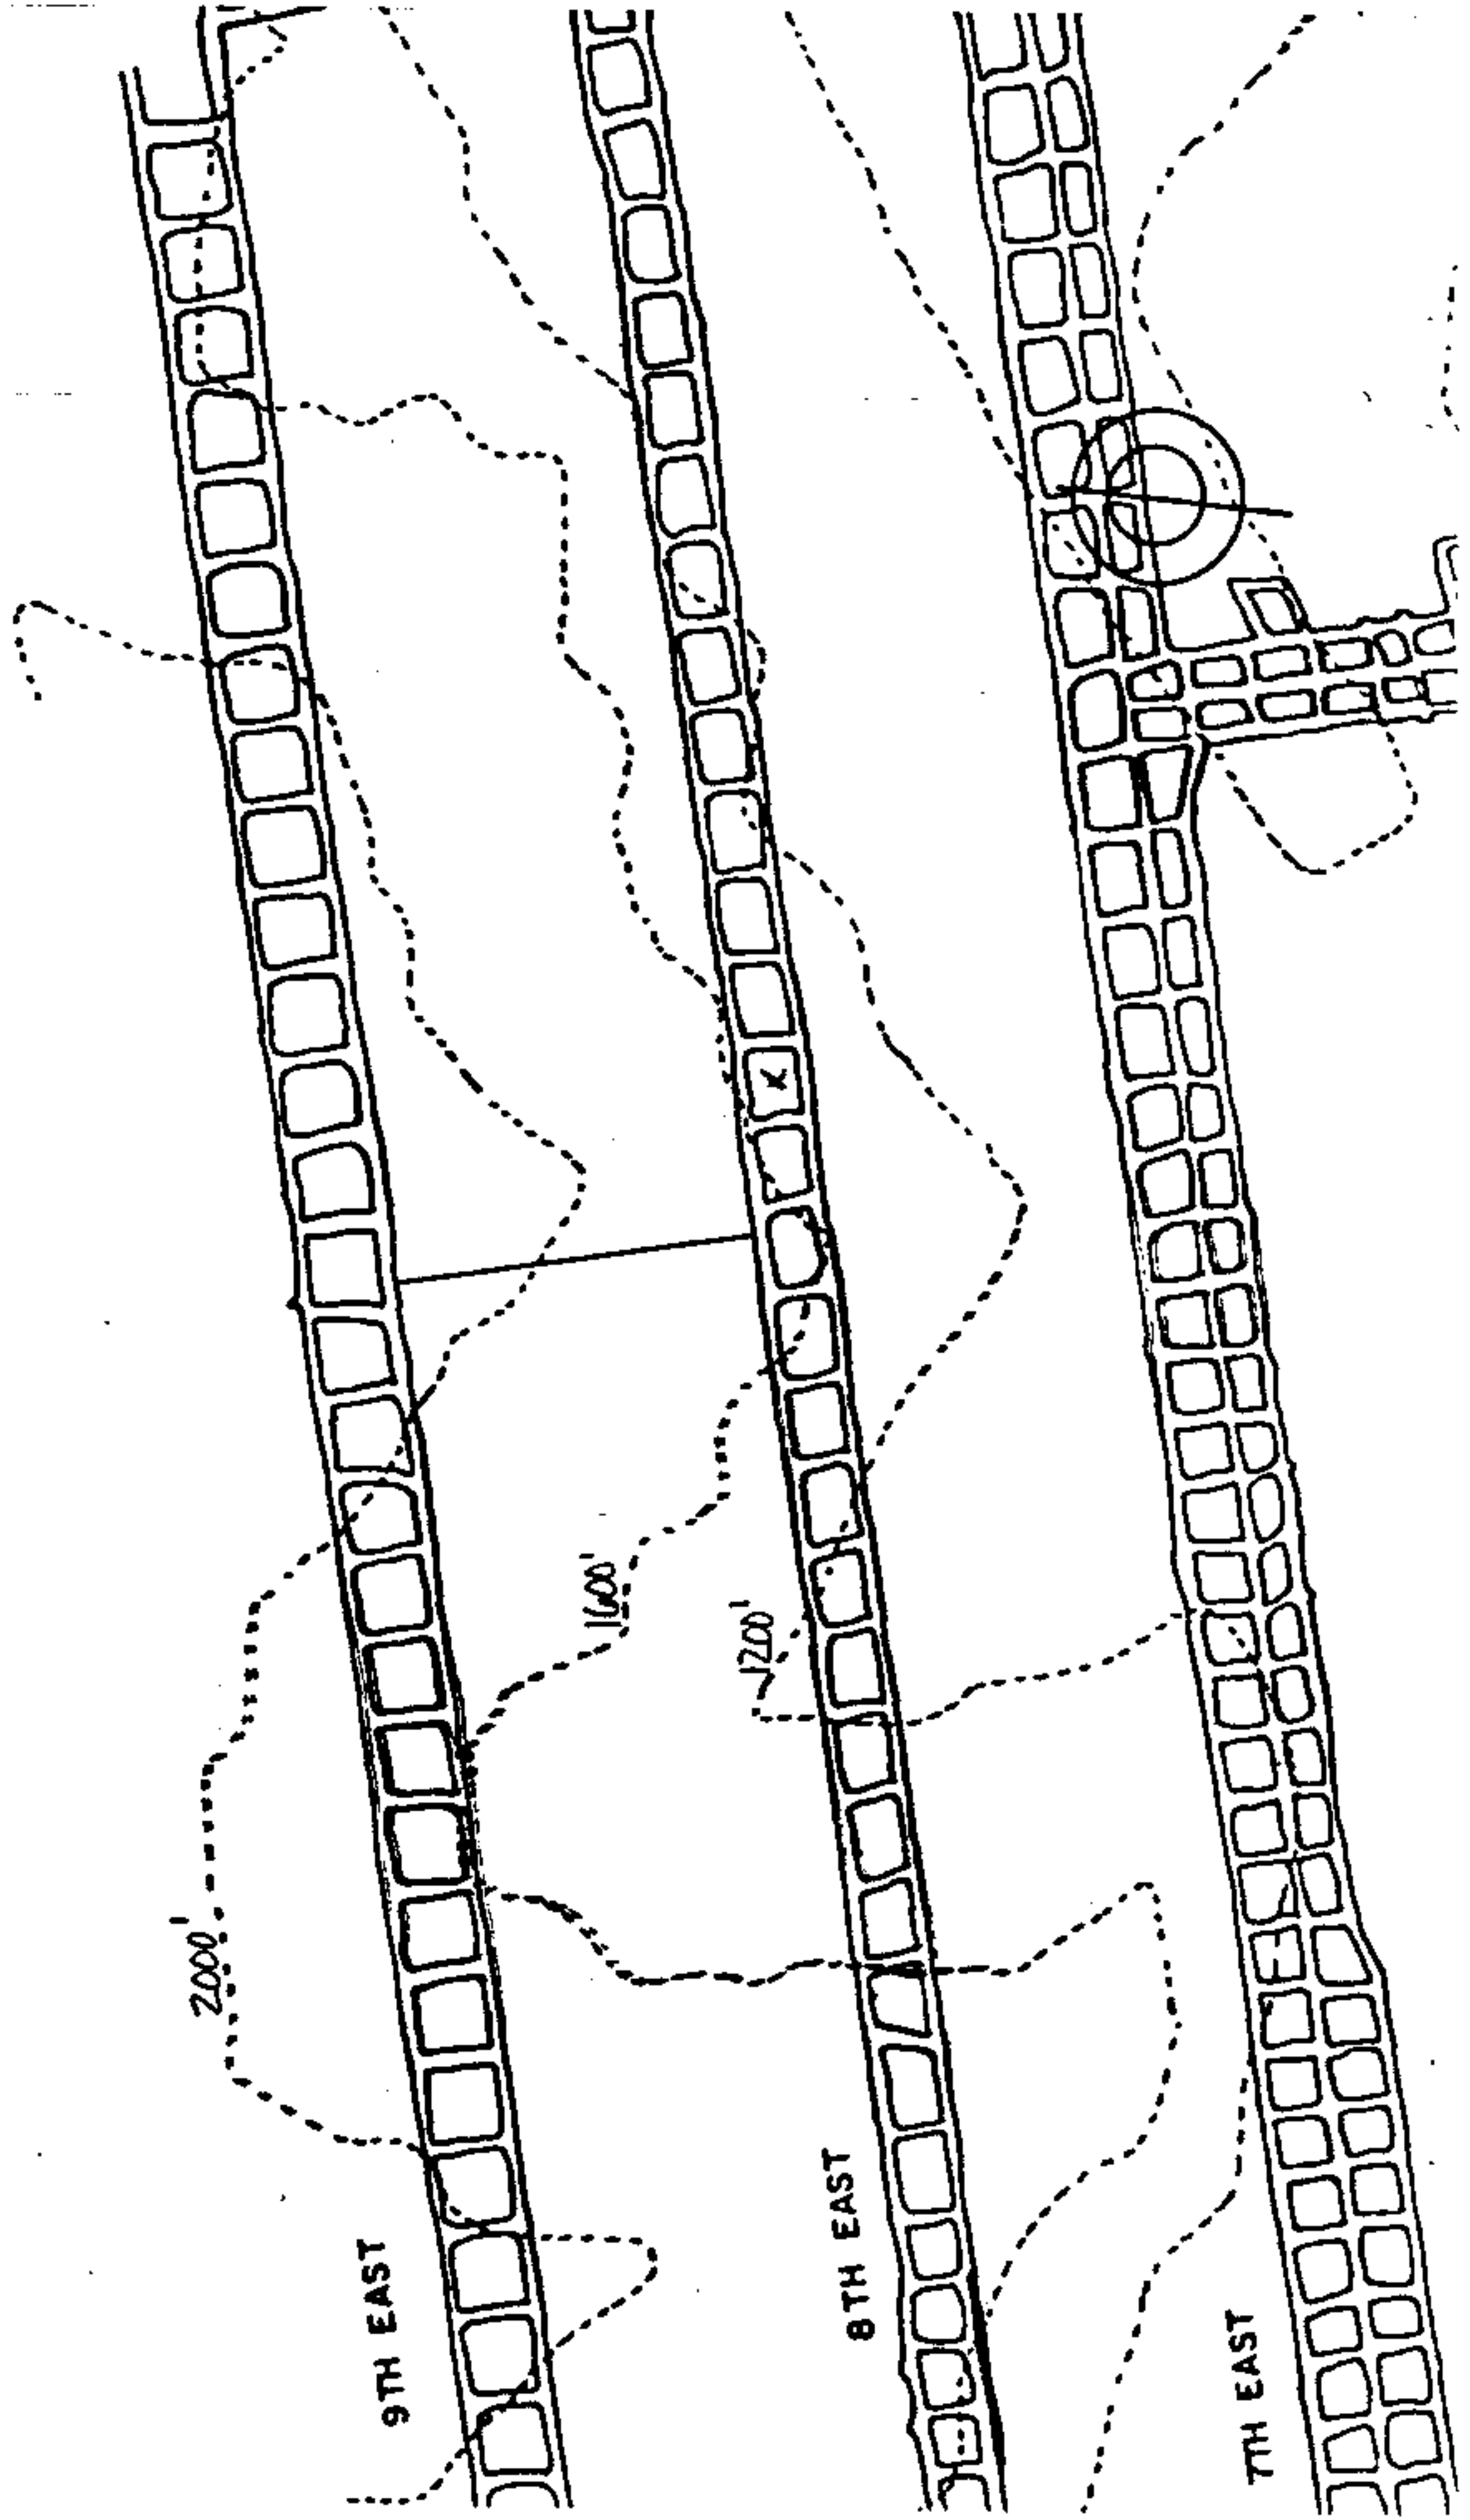
9th East Longwall face at time  
of accident

Shown are elevation contour lines

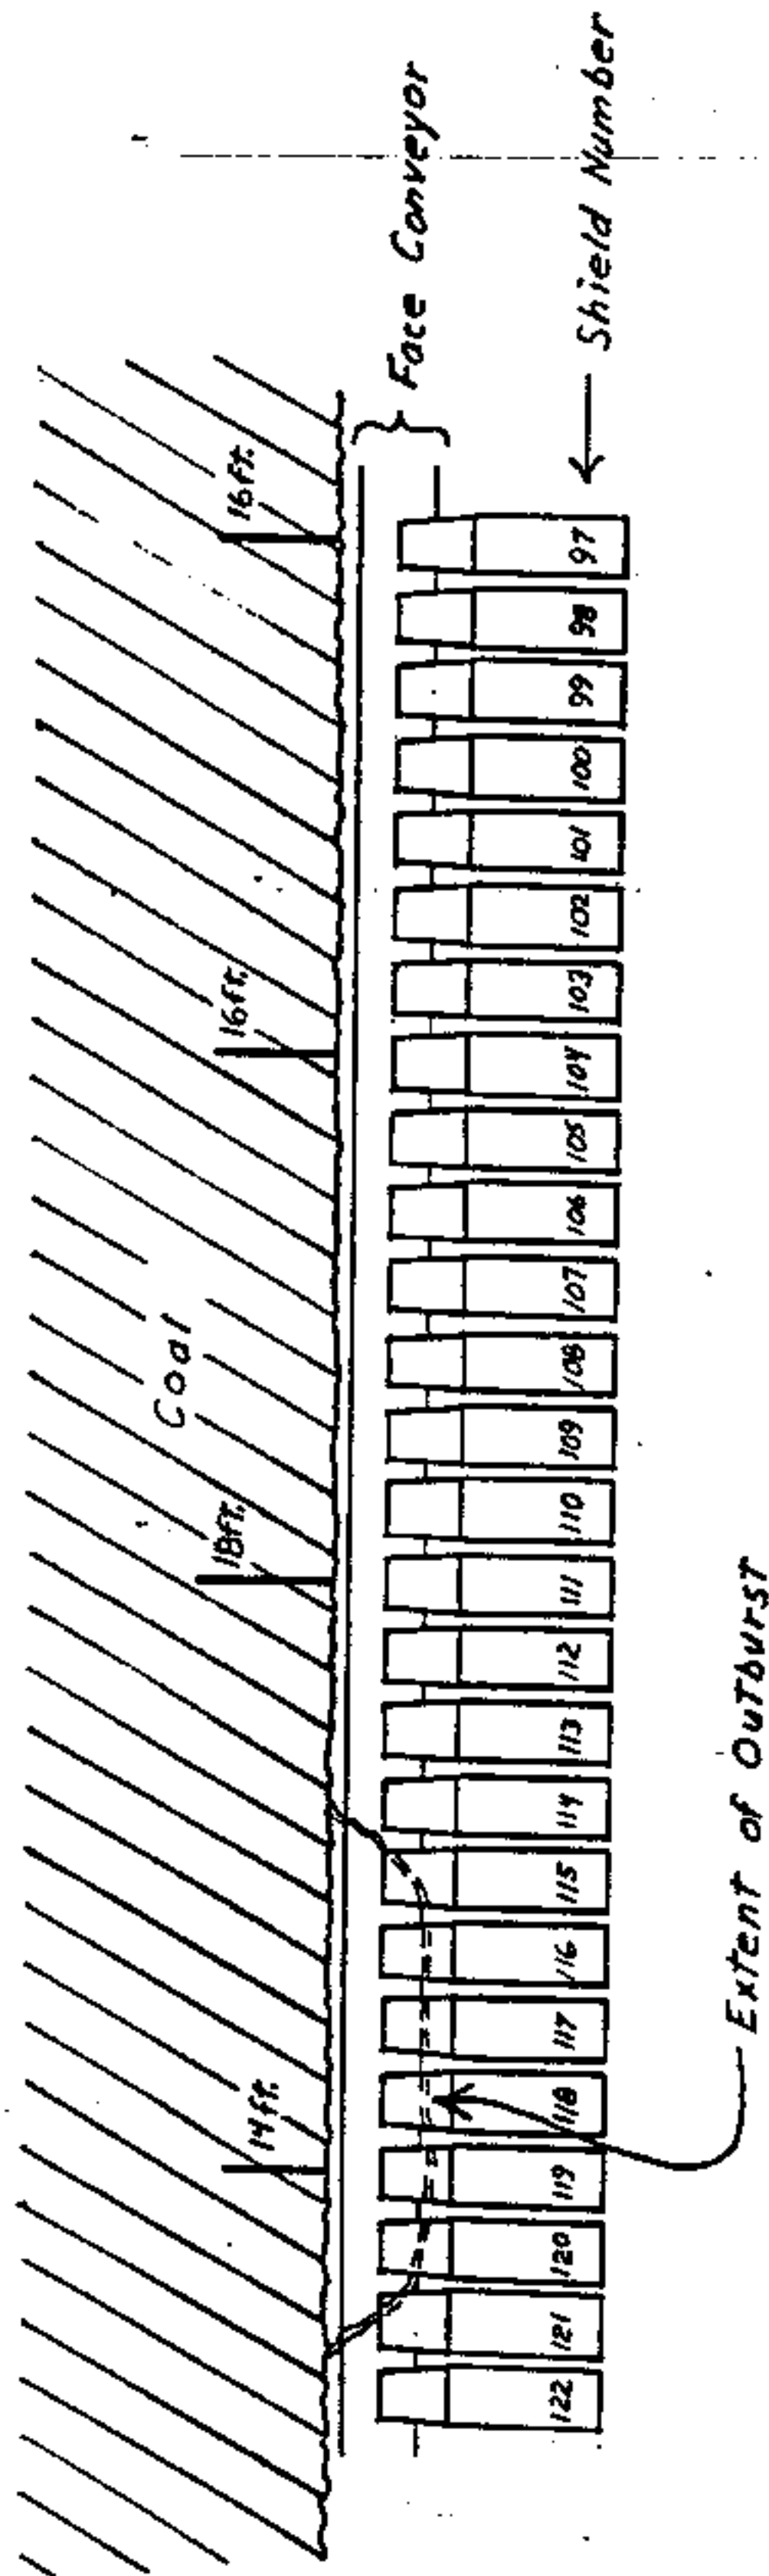
Legend  
Not drawn to scale  
Accident (bounce) scene  
9th East Longwall Section

12. Conflicting statements given by the three drillers did not allow a determination whether or not the actual drilling process triggered the event.
13. The outburst (bounce) accident involved an area 31 feet 6 inches long between shields Nos. 115 to 121.

The method of stress relief, emulsion infusion, being practiced in the tailgate entry could have unintentionally forced the abutment stress toward the already stressed retreating face. The cumulative effects resulted in an uncontrolled instantaneous release of energy accompanied by coal and rock.
